INLET CAY DRAINAGE INVESTIGATION

*Prepared for
Town of Ocean Ridge*

*Prepared by
Higgins Engineering, Inc.*

September 2018

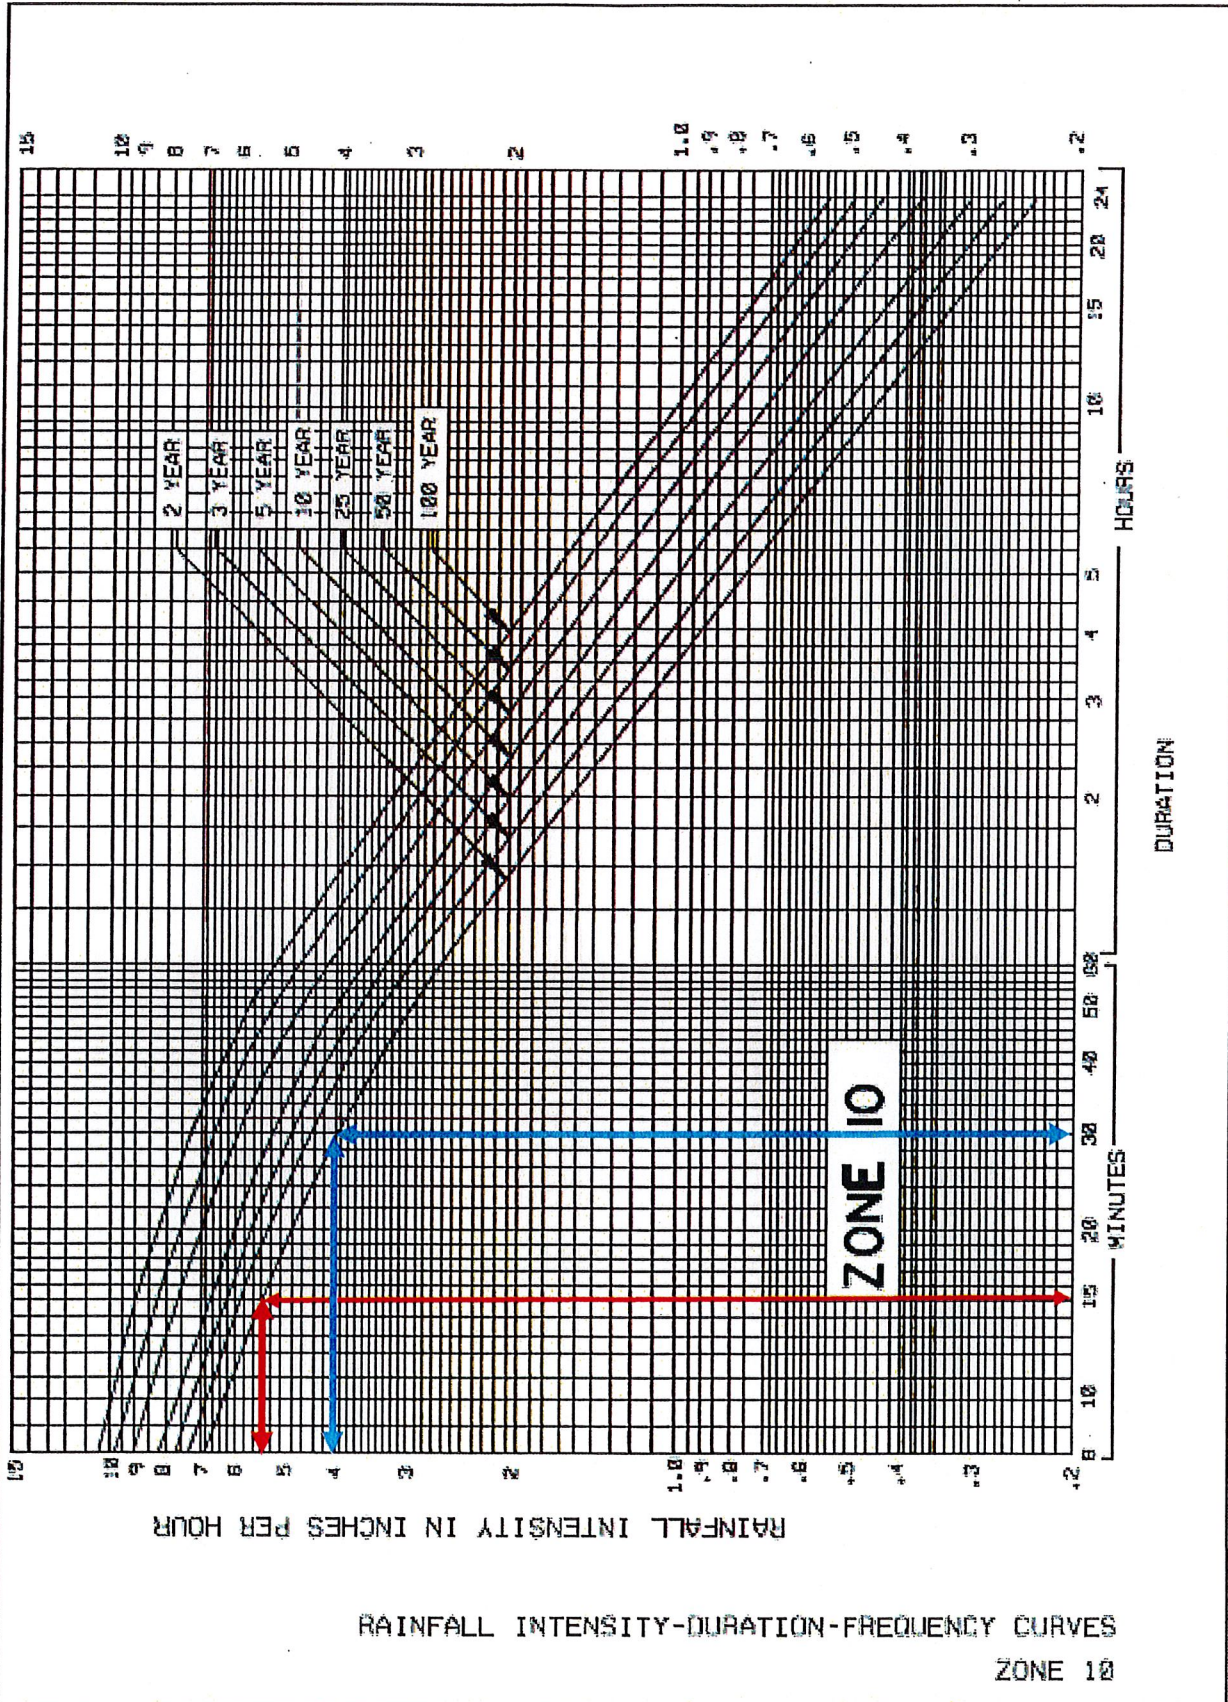
EXHIBIT 1

The Rational Method uses a formula of $Q=CIA$, where Q = peak flows in cfs, I = rainfall intensity in inches per hour, and A is the contributing watershed. The required runoff capacity for this site based upon an expected Time of Concentration between 15 and 30 minutes (for DOT Rainfall Zone 10) with the state **Intensity Duration Frequency Curves** yields expected design rainfalls between 4 and 5.4 inches per hour for the most common (frequent) storm events. See the attached DOT IDF curves for Zone 10 (see Exhibit 1), which is the southeast coast of Florida.

A rough runoff capacity for 4 inches of rain per hour yields a required hydraulic capacity of 31 cfs and for 5.4 inches per hour a needed capacity of 42.1 cfs. These values correspond with a once in 2-year design storm, which is the same as an annual event (the most frequent).

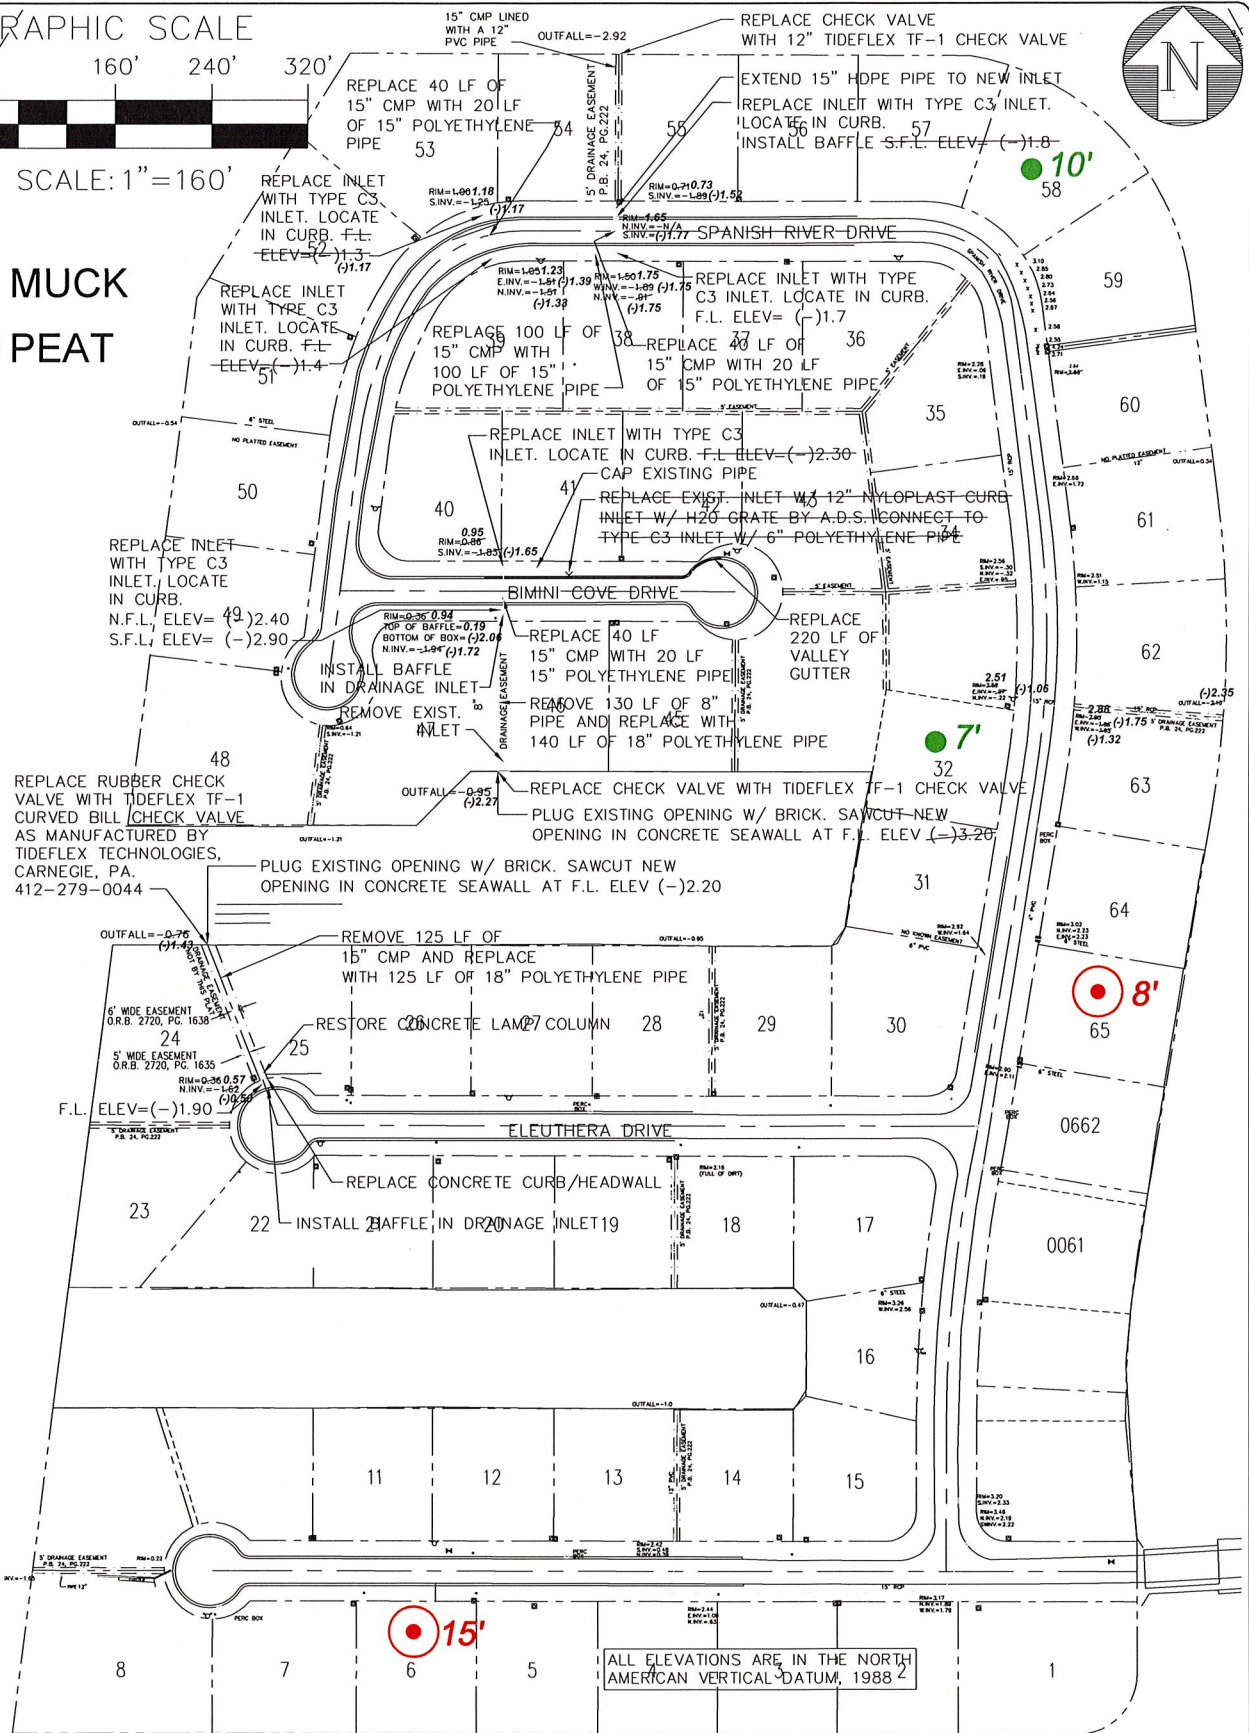
Pursuant to the scope of work, Higgins Engineering have worked with the building department to locate records for any lots with deep soil borings and associated geotechnical reports. We did find four lots with deep soil borings (see Exhibit 2). All four borings recognized a layer of muck or peat lying approximately 5 feet below grade down to as much as 22 feet below grade. This equates to a compressive layer ranging from 7 to 15 feet. Two of the boring listed the layers as peat while the other two are listed the layer as muck. The difference between peat and muck, peat has organic materials and muck consists of fully decomposed organic material. Both peat and muck compress over time when loads are applied to it. An example would be a driveway settling due to the weight of the slab. A map from the Inlet Cay showing the four borings and the thickness of the muck/peat layer is attached. This layer of muck/peat is likely to be made from thousands of years of leaf litter from mangrove trees. Once the layer is fully submerged in groundwater, there is no oxygen to continue the decaying process of peat. It is evident that the original developers of Inlet Cay created this subdivision by excavating the canals and filling the lots over the mangroves. Because of this layer, most of, if not all of the homes have been constructed on pilings including pools. The geotechnical report gave recommendations on piles for the structures which prevent the structures from settling. However, the roadways and driveways will settle with time until the layer reaches its compressibility limit.

All soils are compressible to some extent which is widely variable. There is an index called a Compression Index which measures the compressibility of various soils. For comparison, typical clays have a compression index of 0.3 to 0.9. Peat soils have a compression index of 10 to 15. The amount of settlement that can occur within Inlet Cay varies considerable depending on location, thickness of the layer and how much compression has occurred to date. The only way to get an accurate indication of remaining compressibility is to have a geotechnical firm perform a deep soil boring and analyze the peat/muck in the lab.

It is definite that the Town should continue its practice of obtaining soil borings from a site prior to issuance of a building permit. The Town should also continue to recommend the use of piling beneath all foundations and swimming pools.

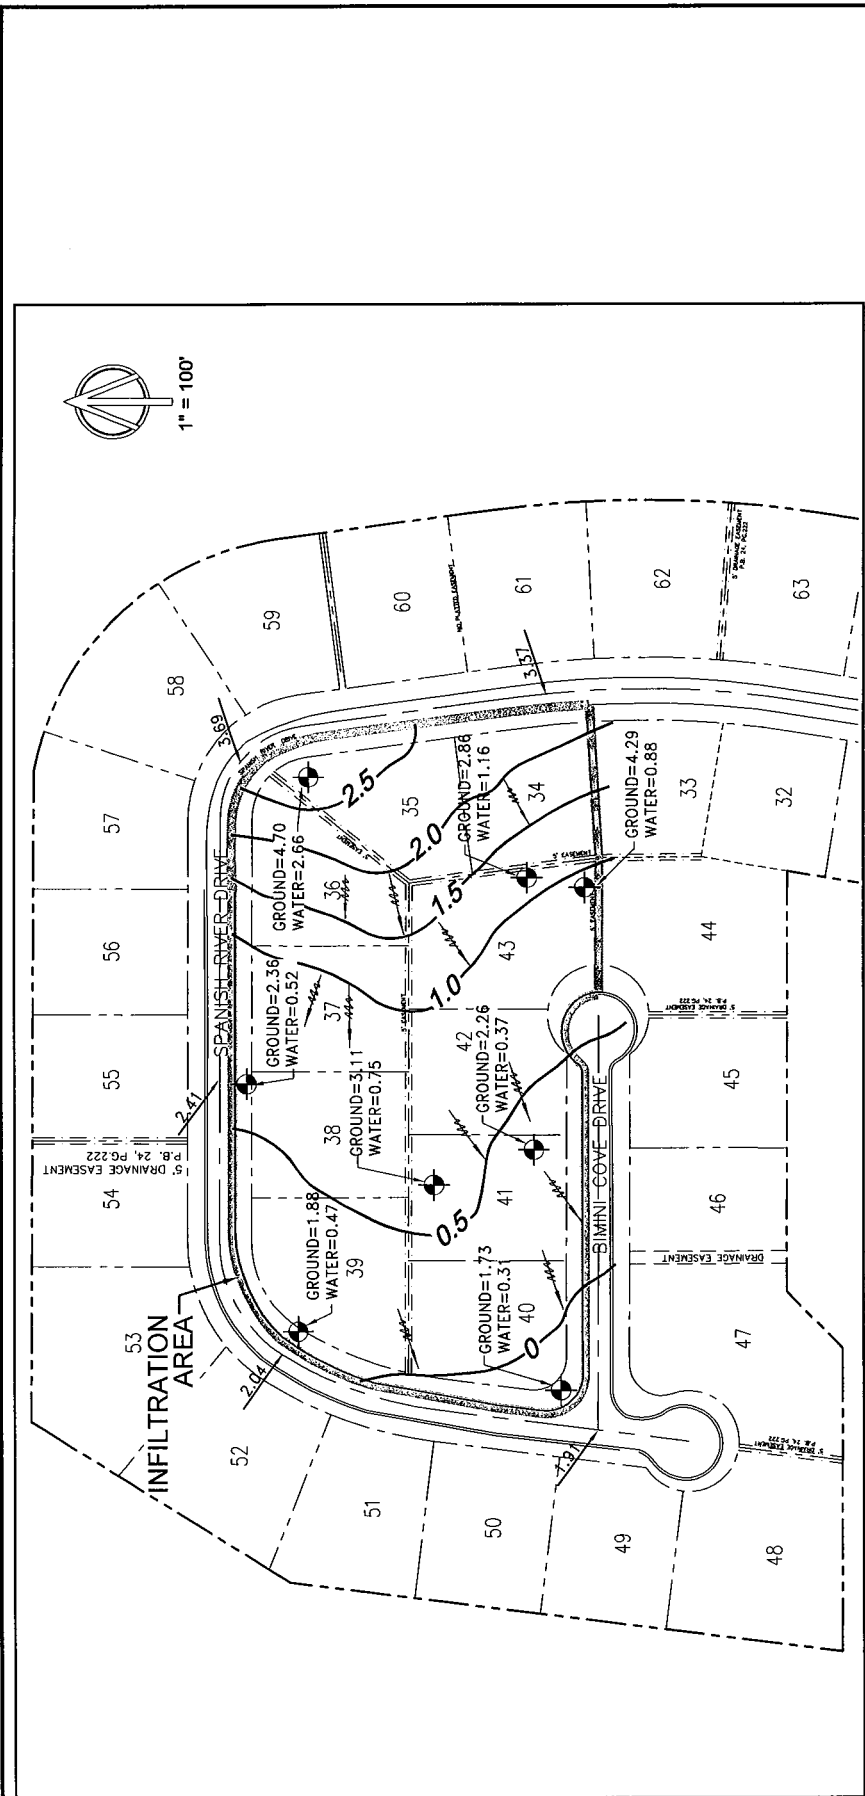
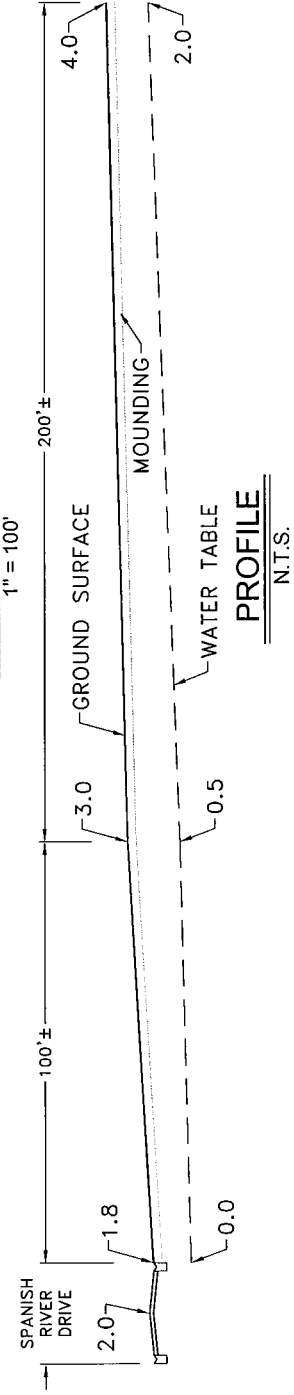
PLAN VIEW
1" = 100'

The Hantush (1967) equation was solved with these parameters, to obtain the groundwater mounding beneath the infiltration area. There are several available calculators that can perform this task. The calculated temporary height above the water table was 1.8 feet.

Exhibit 3 shows the "static" water table based on boreholes situated in different parts of the infiltration area. The predominant flow is from east to west; the average ground elevation is 3 feet NAVD, and the average water table is about 1 foot NAVD. When water mounding occurs as during an intense or concentrated rainfall event, the water table can reach up to 2.8 feet NAVD. This excess water will seep laterally to the roadways in a few days, especially to the west on Spanish River Drive and to Bimini Cove Drive (which are at or below elevation 2.0 feet NAVD), even after the rainfall has stopped.

As a comparison, during the total rainfall between May 13 and May 16, 2018 for the area was 6.2", or a daily average of 1.54". The calculated water table elevation for this storm event was 2.6 ft, which saturated the ground and raised the water table to 2.6 ft NAVD at the roadway at the west side of Spanish River Drive (elevation at the curb side is around 2.0 ft NAVD). The peat/muck layer found at approximately 5 feet below ground is below the water table and fully saturated, and is practically impervious. All flow is laterally in the sands overlying the peat layer. The conclusion that can be reached is there is no artesian spring; all the water that seeps laterally is from local rainfall.
